ROCKY FLATS CLOSURE PROJECT

BUILDING

771

"THE MOST DANGEROUS BUILDING IN AMERICA" READY FOR DEMOLITION

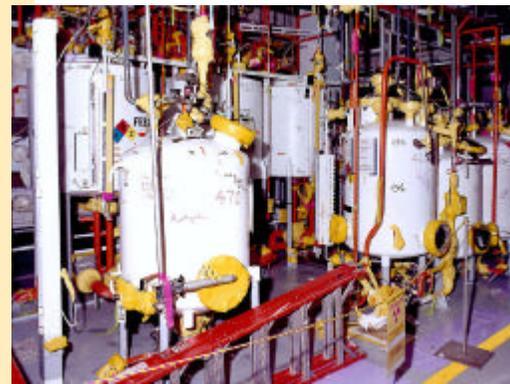
In 1995, tanks containing plutonium solutions.

A report issued in 1994 by the Department of Energy ranked Building 771 as its most vulnerable plutonium facility. The most urgent risks at Building 771 resulted from large quantities of plutonium solutions stored in aging tanks, process piping and four-liter bottles inside gloveboxes.

Plutonium solutions are less stable than other forms of plutonium. Numerous leaks in the building's tanks and piping systems were also identified in the DOE's findings.

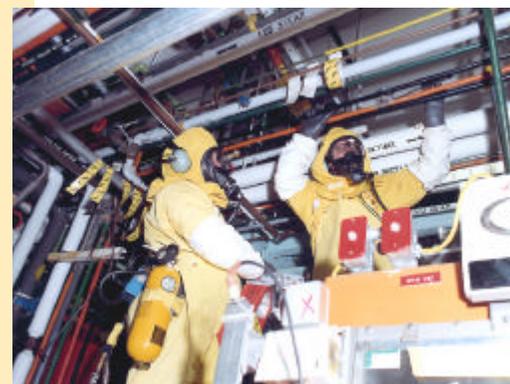
Workers drained and removed more than 11 miles of piping containing plutonium solutions.

Initial cleanup work at Building 771 focused on the highest risks. Workers began stabilizing plutonium solutions stored in bottles in 1993. Workers began draining tanks in 1994 and by 1998 started draining and removing process piping. To ensure that the piping system posed no further hazard and to work with the safest conditions, pipes were removed immediately after draining. Because of the dangers of worker contamination from plutonium solutions and nuclear criticality safety concerns, the work was slow and carefully controlled. Solutions were drained using strict nuclear safety procedural controls.

The last radioactive liquids were drained from process piping in 2001 and, by 2003, the facility was cleaned to the point that a nuclear criticality accident was improbable.

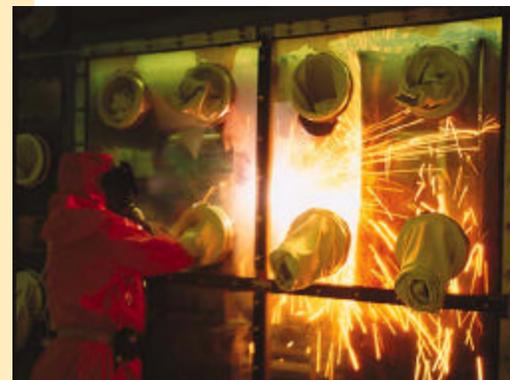
Using plasma-arc torches to cut up stainless steel gloveboxes significantly improved safety.

- **Plasma-arc torches:** Large, highly-contaminated stainless steel gloveboxes and other large pieces of equipment need to be cut up to fit in standard waste shipping containers. To do this at Rocky Flats, workers use mechanical Sawzalls and stainless steel “nibblers” to cut equipment within the confines of a tent structure erected to contain the spread of contamination. A notable feature of glovebox cutting at Building 771 was the development of plasma-arc cutting of gloveboxes which reduced exposure to workers and, because of the light weight compared to mechanical cutting equipment, eliminated industrial and ergonomic hazards.

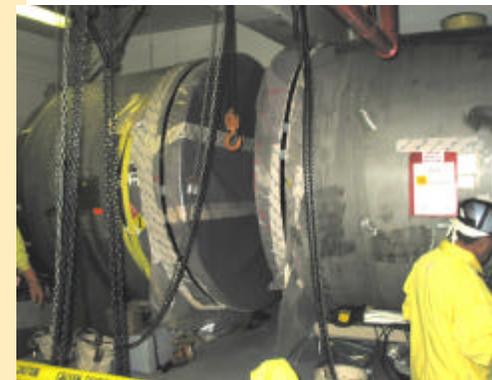
Large tanks also had to be cut into pieces to fit in radioactive waste shipping containers.

Glovebox, tank and equipment dismantlement: Removing hundreds of highly-contaminated gloveboxes and tanks, many the size of a railcar, often requiring size reduction and significant decontamination efforts.

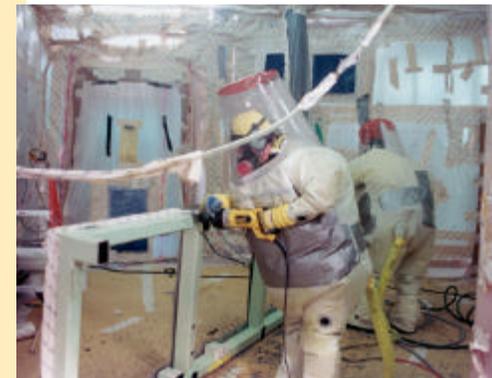
Workers were required to wear cumbersome protective clothing while dismantling equipment.

Cutting the contaminated gloveboxes, tanks and other equipment into a size that would fit into waste containers was difficult and rife with hazards. Workers wearing cumbersome protective clothing cut up glovebox sections that contained up to three-quarter-inch-thick stainless steel.

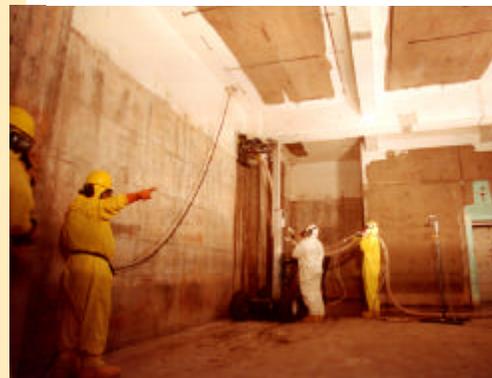
Workers use ultra high pressure water jets to decontaminate the structure.

Structural decontamination: Removing residual contamination from the walls, floor and ceiling of the structure using ultra high-pressure water spray that blasts away layers of concrete.

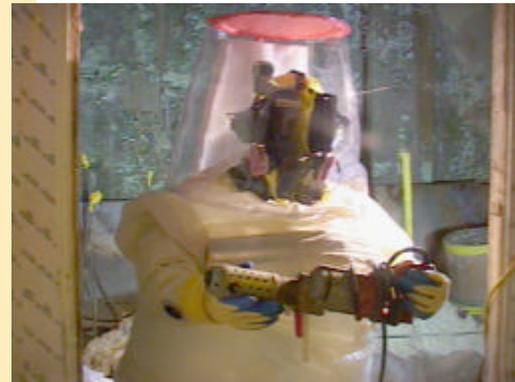
A worker removes an old, abandoned jackhammer from the "Infinity Room."

Workers also faced hazards posed by some of the most contaminated areas at Rocky Flats. Room 141, the building's infamous "infinity room" – so named because radiation levels inside pegged radiation detection equipment 25 years ago and prompted operators to seal and abandon the room – posed significant challenges. Initial readings in the room in 2002 revealed airborne plutonium contamination levels 2,000 times higher than maximum limit for safe entry. An innovative approach to control airborne levels using a glycerin-based fog, remotely pumped into the room, caused contamination to adhere to surfaces. Airborne contamination was reduced below limits, allowing workers to enter in supplied air breathing suits to remove and package equipment stored in the room and spray fixative to further control contamination.

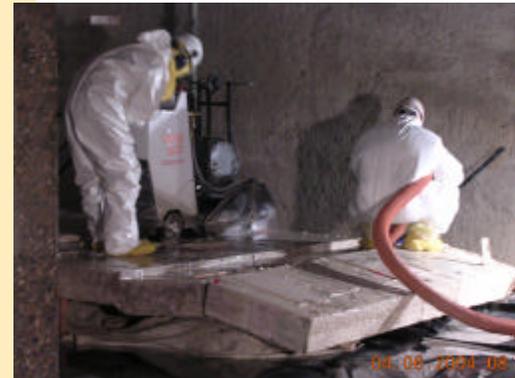
The walls, floor and ceiling of the "Infinity Room" were cut into blocks for shipment to a radioactive waste disposal site.

The final and most labor-intensive job involved removing the room itself. Workers developed an innovative approach using diamond wire saws to cut the 3-foot-thick ceiling, floor and walls and

then used concrete saws to cut the slabs into blocks suitable for packaging. The entire room was cut up and shipped to the Waste Isolation Pilot Plant in New Mexico, a transuranic waste receiving facility.
